REPORT OF DR. FOLKERS ROJAS, P.E.

DATED this 18th day of February 2025.

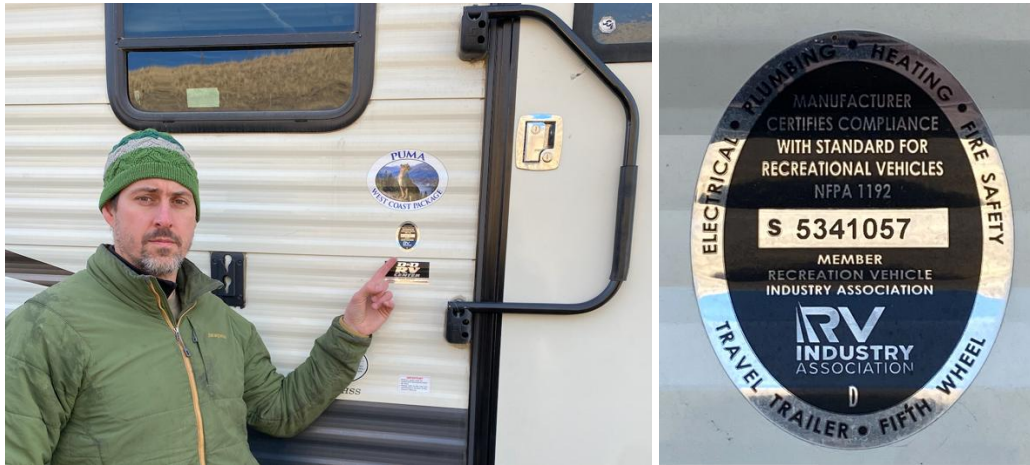
29. Forest River, Inc. produces towable RV units with seven-way wiring that is not compliant with applicable standards. When I refer to wiring or wiring defects I am referring to the seven-way wiring. As shown in Figure 1, Forest River attached an RV Industry Association decal (“RVIA Seal”) stating that the “manufacturer certifies compliance with the Standard for Recreational Vehicles, NFPA 1192.” The National Fire Protection Association 1192 Standard (“NFPA 1192”) low voltage section refers to the RVIA LV Standard. Both the NFPA 1192 and RVIA LV Standard are the applicable standards for the towable RV (“Applicable Standards”). Recreational vehicle original equipment manufacturers (“RV OEMs”) are responsible for abiding by the Applicable Standards.

Figure 1. Dr. Matthew Angle, on November 13, 2024, inspection of the 2019 Puma with the RVIA Seal denoting that the vehicle complies with NFPA 1192

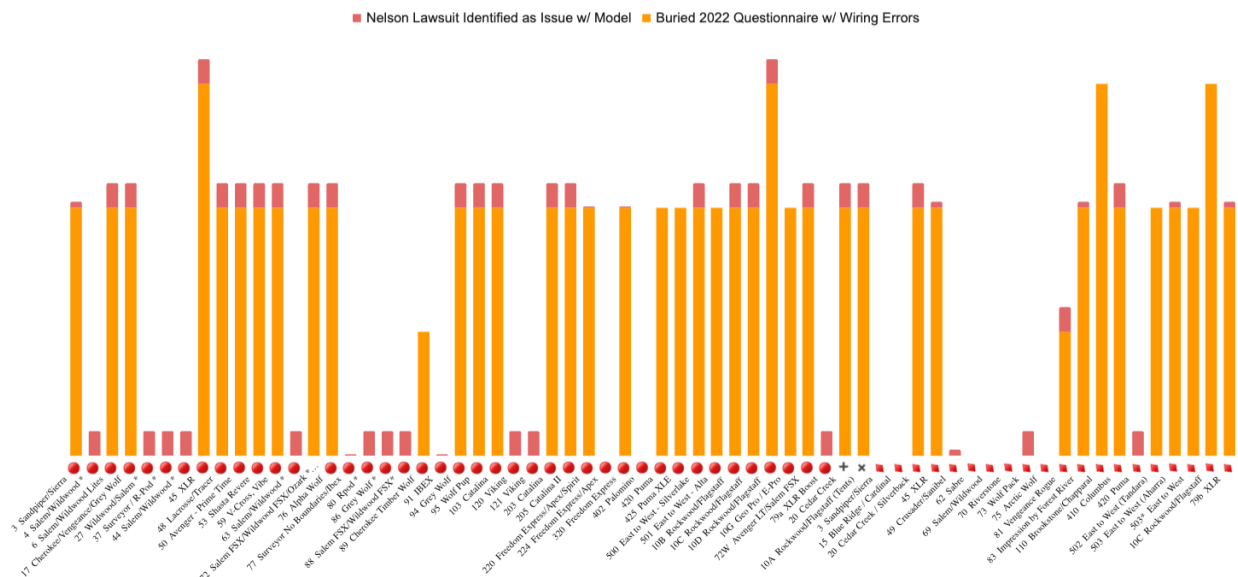
43. Per the request of Forest River Office of Corporate Compliance (Director: Leo Akins) to the “plant inspectors” of the Office of Codes and Standards (Director: Matt Gingerich) were to perform the 2022 Survey as a response to the claims in the Nelson Lawsuit. The 2022 Survey indicates that at least 39 out of 64 plants had unprotected seven-way wiring. Forest River failed to provide the documents in discovery for 2.5 years in the Nelson Lawsuit. The 2022 Survey contains details on 20 fifth-wheel plants, 1 tent camper trailer plant, 1 destination trailer plant, and 42 travel trailer plants (ForestRiver0030448-30520). The withheld 2022 Survey only came to light on January 15, 2025, after the deposition of Rodney Smith. Figure 5 shows the review of the 2022 Survey, where every vertical orange column denotes an error with the seven-way wiring, and the brown caps are models that the Field Investigation identified as having wiring defects. In short, Forest River was fully aware of the problem in the summer of 2022. Furthermore, Forest River did not disclose the electrical wiring errors to RVIA, NHTSA, dealers, or any customers.

Figure 2. 2022 Investigation shows that 40 out of 64 plants had one or more errors that resulting in seven-way wiring defect. Key: ● Travel trailers, + Tent Campers, ✕ Destination Trailers, and ■ Nelson Lawsuit Field Investigation identified.

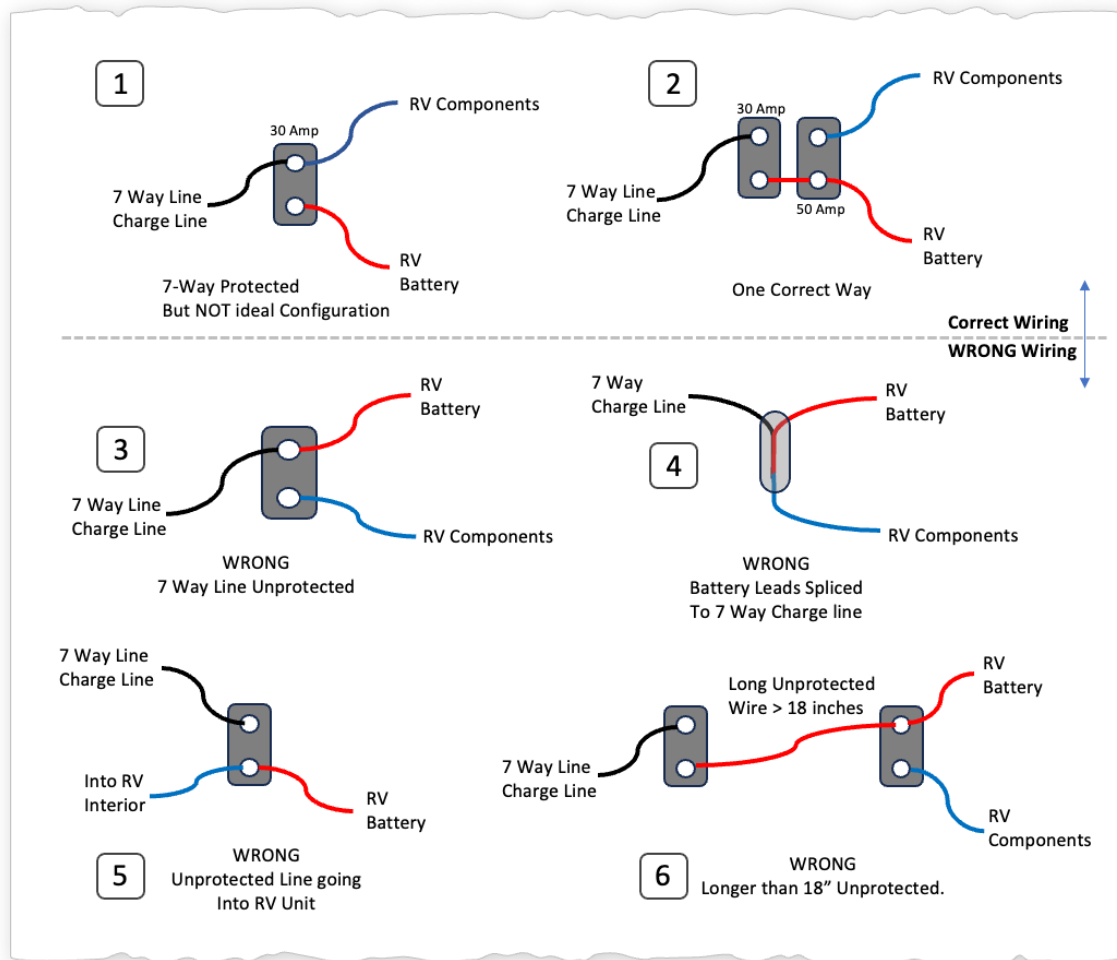
60. Forest River's own electrical system drawing number **12-VOLT** (ForestRiver0000012), dated June 29, 2000, has a correct electrical system configuration. Thus, Forest River has been in possession and aware of a correct electrical system sketch. At about the same time, Forest River also generated an electrical system drawing number **E-01-C** (drafted on August 1, 1999, and released on September 8, 2003) that was in violation of Applicable Standards. The main difference between a safe and compliant electrical system and a fire hazard can be summarized visually in Figure 9. By enabling an effective material cost saving of ~\$1.01/rv unit (on one 30-amp breaker, 2 screws, and a short 3-inch max length of 10-gauge wire), Forest River has placed and continues to place its customer and the general public in danger.

Figure 9. Electrical system wrong way and right way both present in existing Forest River electrical system drawings and Field Investigations. Note that the 7 Way charge line should be protected by a 30-amp breaker since it is a 10-gauge wire.

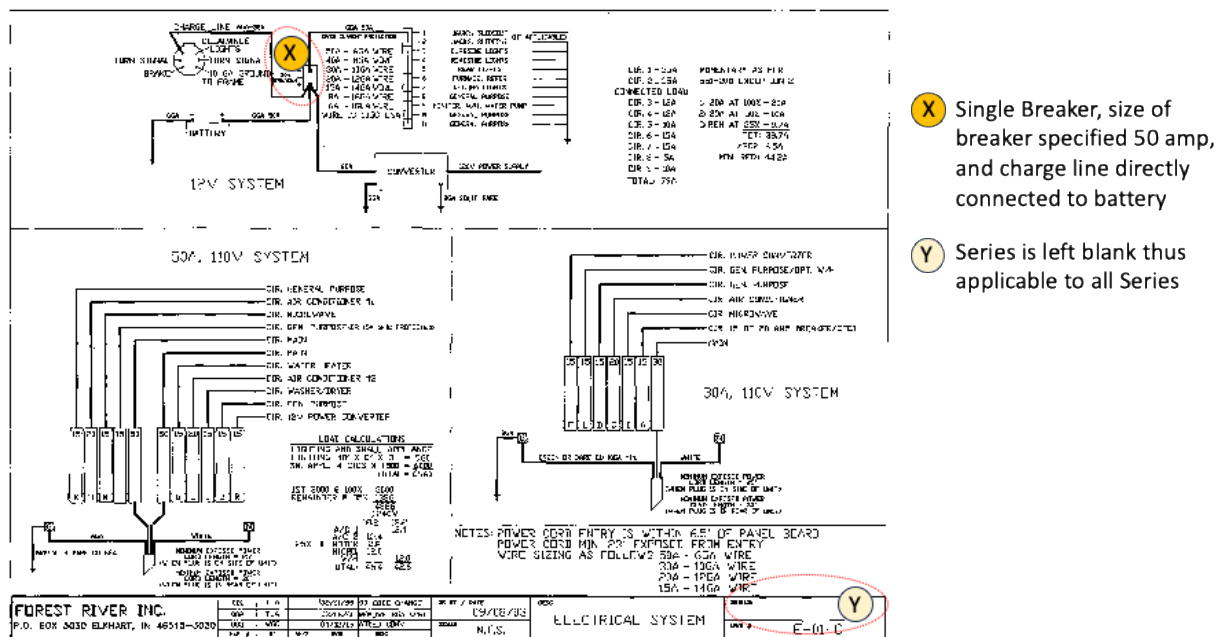
70. The second drawing, dated September 8, 2003, is where Forest River starts to produce conflicting information for its electrical system. In drawing **E-01-C** (ForestRiver0020997), Figure 13, for the electrical system the errors begin. A single breaker (50

amps) is used, and the seven-way wiring charge line is directly connected to the positive terminal of the breaker where the battery is connected (label X). Note that the drawing does not specify the series of RV that are impacted by this schematic (label Y). It is also important to note that this is not a draft preliminary drawing since there have been at least three modifications/updates made to the drawing since its initial release date. The last modification for drawing **E-01-C** is dated April 2, 2009.

Figure 13. Forest River Electrical System drawing E-01-C. (ForestRiver0020997)

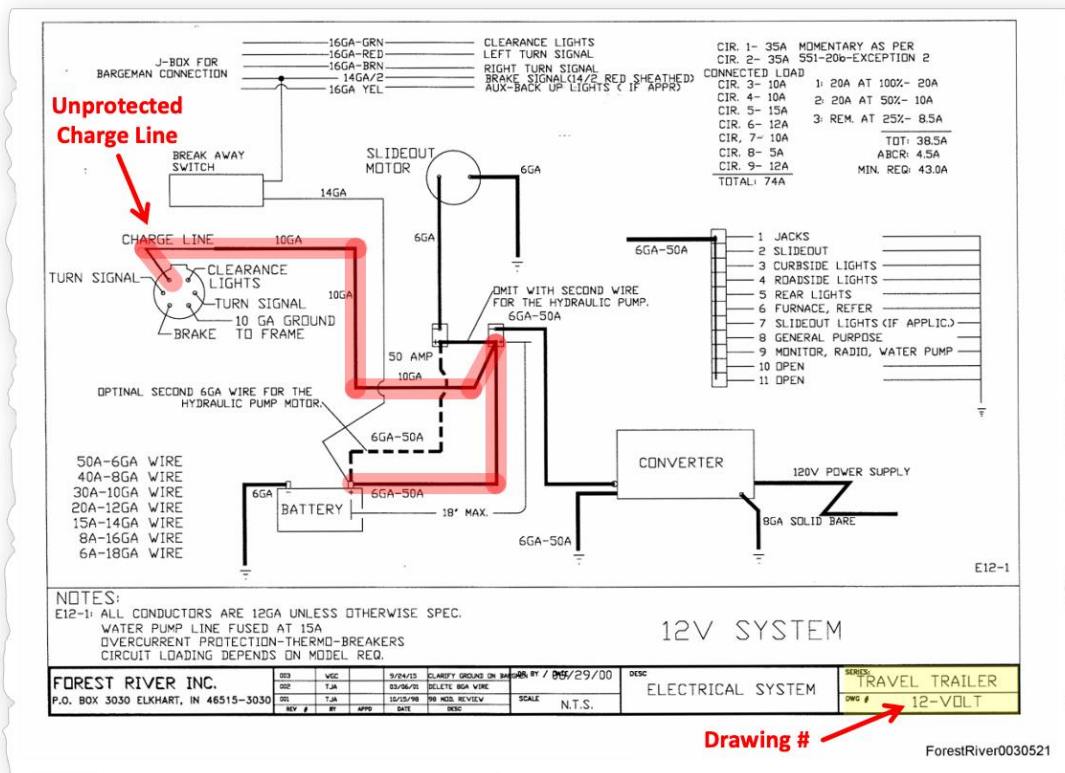
82. The wiring schematic, also labeled DWG# **12-VOLT** (Series Travel Trailers), clearly shows that there is NO protection on the seven-way wiring as depicted in Figure 15. The 30-amp breaker that exists on the 5th Wheel drawing was removed from the travel trailer drawings.

83. The travel trailer electrical system schematic corroborates Matt Gingerich statement that: “On a travel trailer there is no over-current protection on the charge line.” (M. Gingerich Dep. 20:23-24). Forest River's missing overcurrent protection on the seven-way wiring is a violation of applicable standards.

Figure 15. Forest River schematic diagram (ForestRiver0030521) for the travel trailers with the same drawing number (12-VOLT)

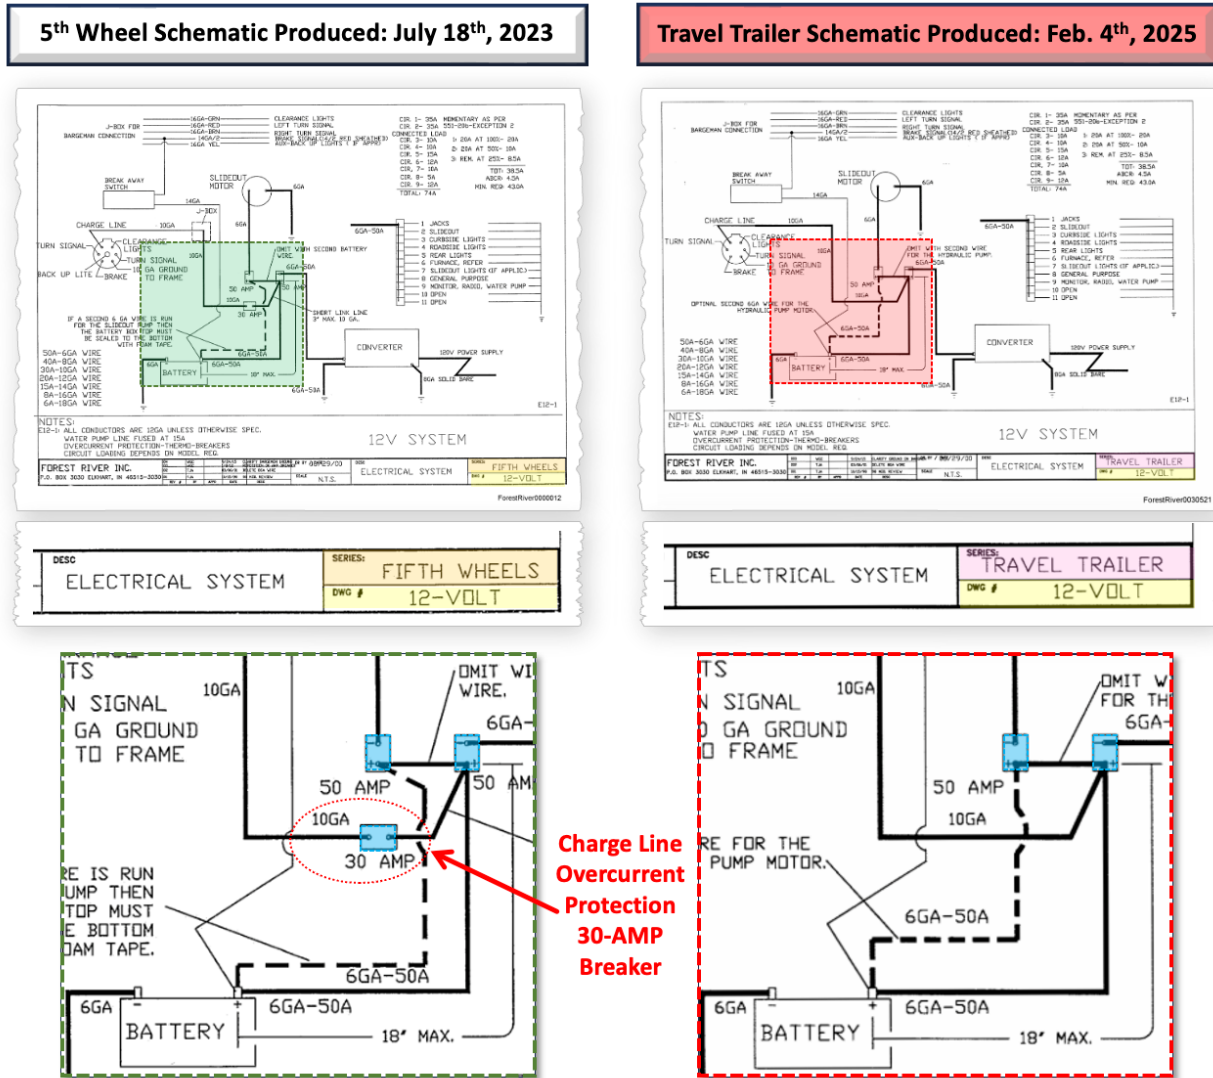
84. A side-by-side comparison, Figure 16, of the fifth wheel and travel trailer electrical system unequivocally shows the removal the 30-AMP breaker responsible for overcurrent protection of the charge line has been removed on the travel trailers.

Figure 16. Comparison between 12V Electrical System between Fifth Wheels (ForestRiver0000012) and travel trailer (ForestRiver0030521) schematic diagram

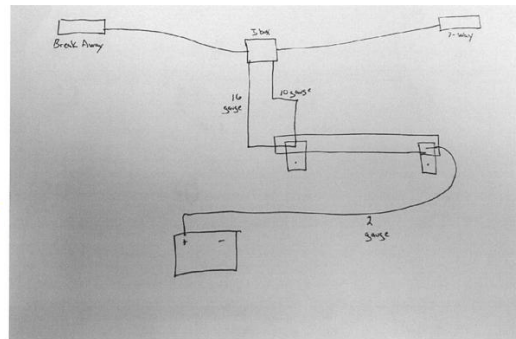
99. The 2022 Survey, example shown in Figure 18, does not reference any of the four electrical wiring schematics discussed in section VII.B of this report. Instead, the 2022 Survey references a single diagram of the Forest River Electrical Guidelines (ForestRiver0005021). Per the sketches drawn by the inspectors and their written statements it is clear that the plant inspectors were aware that there was no over current protection on a number of their products.

CHARGE LINE IS NOT PROTECTED. CHARGE LINE ENTERS SAME SIDE OF BUSBAR AS BATTERY.
3. Check for wire protection along the run. Is the wire protected from sharp edges and from getting pinched?
 - a. **Yes** or No
 - b. If no, what needs to be done to protect the wire.

Figure 18. Forest River 2022 Survey sent out the inspectors (ForestRiver0030465)

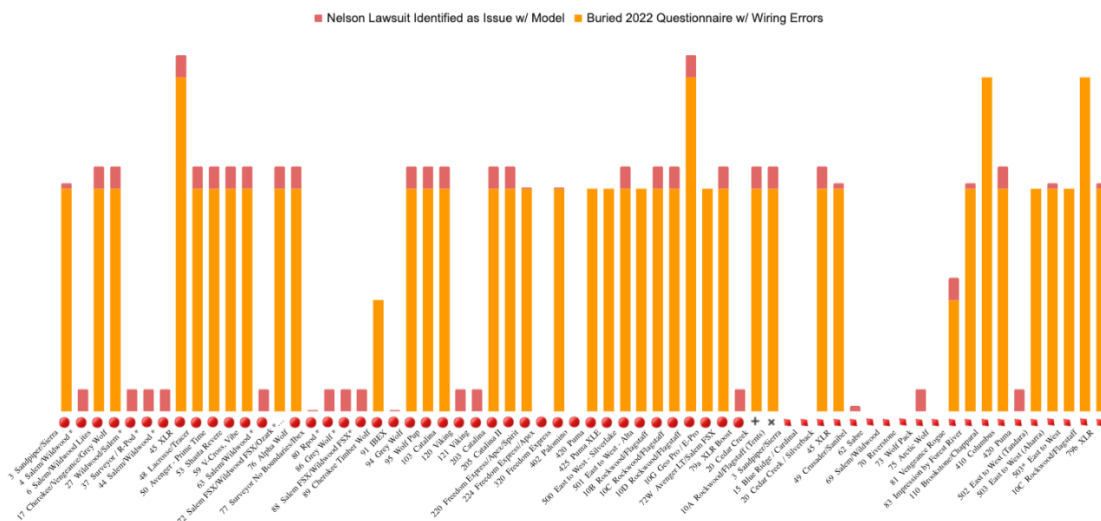
101. Figure 19 shows a visual representation of the 2022 Survey where every vertical orange bar is a plant producing units with unprotected wiring. The red caps are indicators that the data from the Field Investigation performed by Dr. Matthew Angle and I in 2024 also showed the unprotected wiring. Note that although some of the 2022 Survey sketches showed protected wiring, the Field Investigation showed that some of those models were produced with seven-way wiring defects.

Figure 19. Processed data from the 2022 Survey. The red caps ■ are indicators that the data from the Nelson Lawsuit Field Investigation indicate unprotected wiring in those models. The ‘*’ means that there are several plants producing said model, and the Field Investigation only shows which models have unprotected wiring. Full page image available

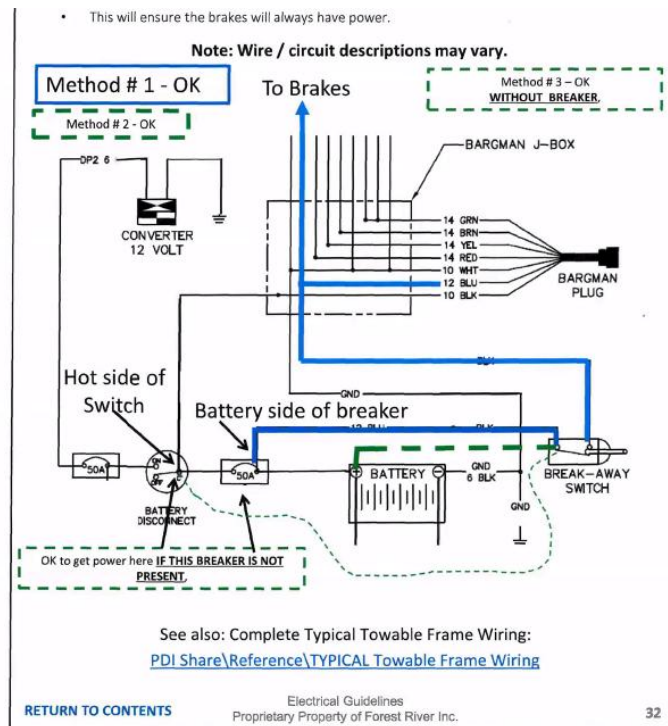
ForestRiver0005021

105. For Method 1 and Method 2, the breaker closest to the battery is a 50-amp, and it should be a 30-amp to properly protect the seven-way wiring, as shown in Figure 21 and Figure 22 respectively.

106. Method 3, which does not have a breaker between the battery disconnect and battery leaves the seven-way wiring completely unprotected as shown in Figure 23.

Figure 20. Excerpt from Electrical Guidelines (pg. 32) (ForestRiver0005021) that show Method 1, Method 2, and Method 3 referred to by the 2022 Survey.

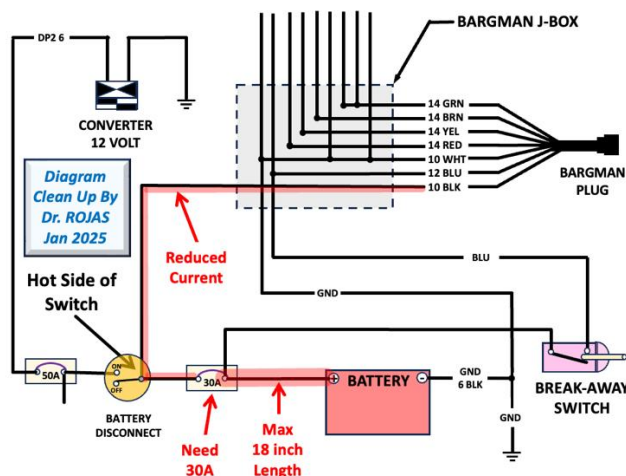
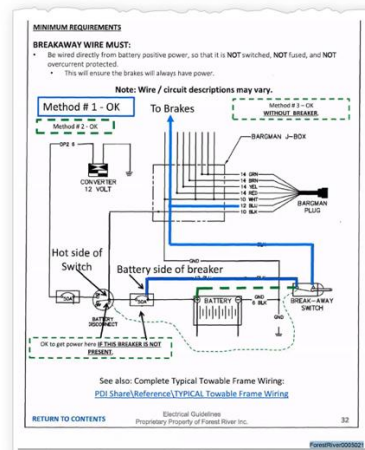
Method # 1 - OK

Figure 21. Corrected Method 1 schematic of the Forest River Electrical Wiring Pg 32 with an overlay of the current. The corrections that are needed is changing one of the 50-amp breakers to a 30-amp, and the maximum distance between the battery and the first breaker is 18 inches.

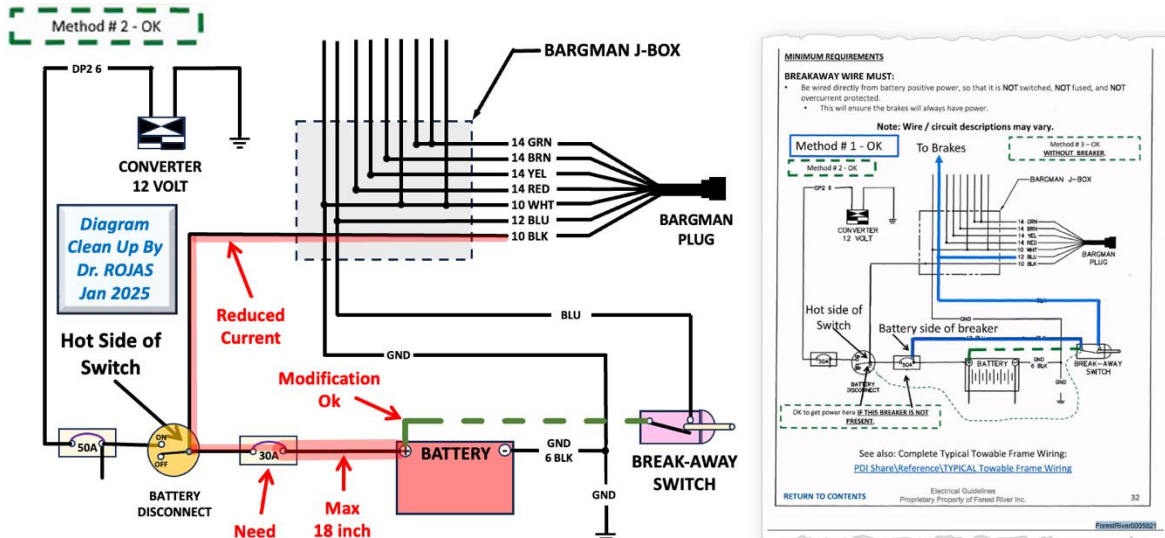
Figure 22. Corrected Method 2 schematic of the Forest River Electrical Wiring Pg 32 with an overlay of the current. The corrections that are needed is changing one of the 50-amp breakers to a 30-amp, and the maximum distance between the battery and the first breaker is 18 inches.

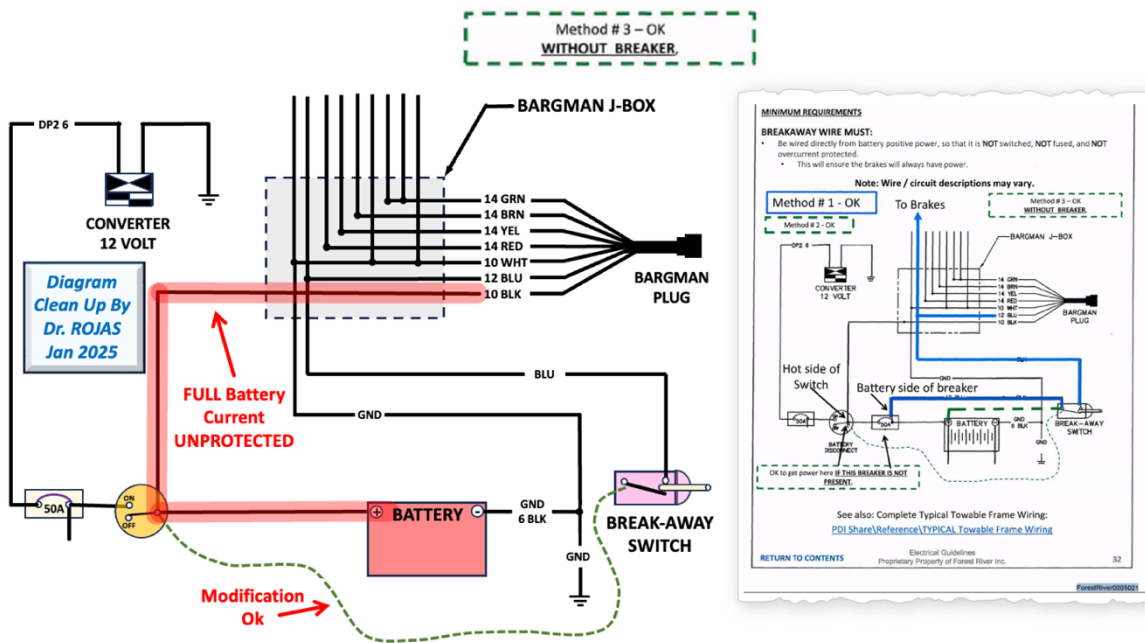
Figure 23. Method 3 schematic of the Forest River Electrical Wiring Pg 32 with an overlay of the current. The way produced it can NOT be corrected by changing a breaker size. This is consistent with some travel trailers where the seven-way wiring is spliced directly to the positive battery terminal.

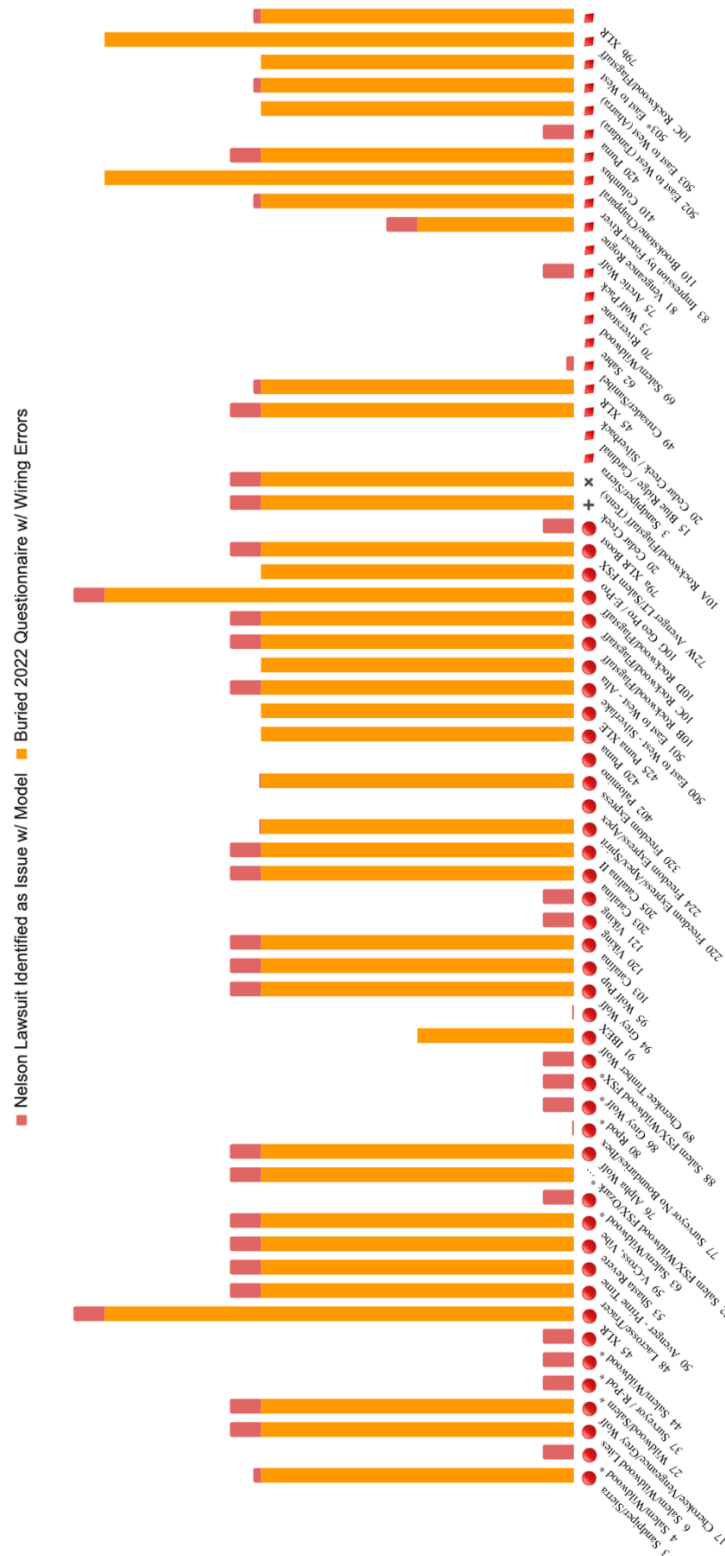
115. can be visualized as columns as shown in Figure 25 (large size). Each vertical orange column is a plant with one or more code violations with the seven-way wiring.

Figure 25. 2022 Survey Results in large columns format. Key: ● Travel trailers, + Tent Campers, ✕ Destination Trailers, ◆ Fifth Wheel, and ■ Nelson Lawsuit Field Investigation identified.

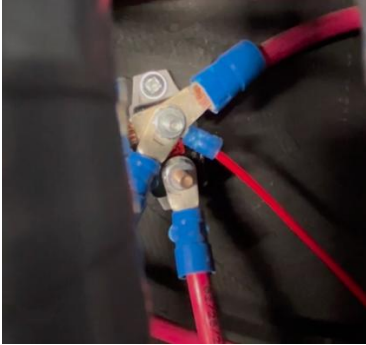
<p>Almost Touching</p>
<p>Model: Ahara East to West</p> <p>VIN: 5zt3ah3b8n9100287</p> <p>Fabricated Date: 5/19/22</p>

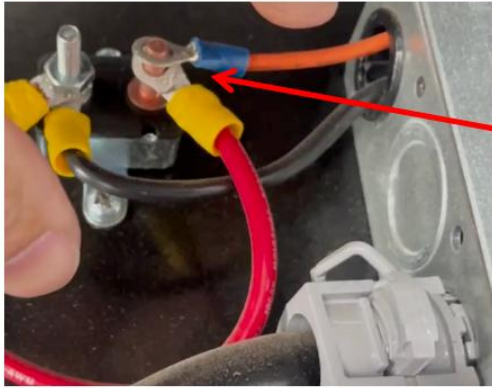
breakaway switch is triggered, the trailer will not break because there may not be power due to this loose end. On another travel trailer, Salem Cruise Lite, the missing nut on the mini-breaker is on the battery lead. If that 6-gauge battery lead does come off and makes contact with the chassis with is ground, then the consequences is burning a 6 gauge wire right under the flooring material of the travel trailer.

Details	Photo w/ Incorrect Wiring
Model: Sandstorm VIN: 4x4tsca2xrc012493 Fabricated Date: 1/31/2024

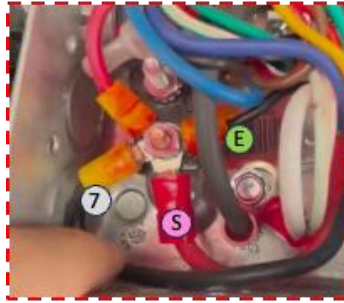
<p>Model: Viking</p> <p>VIN: 5zt2vwnb4sj134948</p> <p>Fabricated Date: 7/11/24</p> <p>Plant: White Pigeon, Michigan</p>	<p>Wrong!</p>

134. Some noteworthy violations of overcurrent protection examples are shown in Table 9. As shown by comparing the Campsite Reserve and the Viking model, plants in different states continue to fabricate with the wrong electrical wiring.

<p> E Break Away Line S RV Battery 7 7-Way Charge Line </p>
--	--

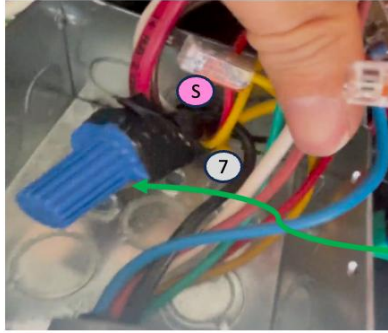
Details	Photo w/ Incorrect Wiring
<p>Model: Wildwood XLite</p> <p>VIN: 4x4twdz29s7379253</p> <p>Fabricated Date: 8/6/2024</p> <p>Plant: Middlebury, Indiana</p>	<p>Wildwood Xlite (9253)</p>

135. In one Wildwood XLite, a wing wire connector was used to connect the seven-way wiring charge line to an unprotected RV battery line. A Wildwood FSX Platinum Fabricated 8/27/24 was inspected on 9/20/24 and has the wrong electrical wiring.

<p> E Break Away Line S RV Battery 7 7-Way Charge Line </p> <p>No Breaker Wirenut connects Battery to 7-Way Charge Line</p>

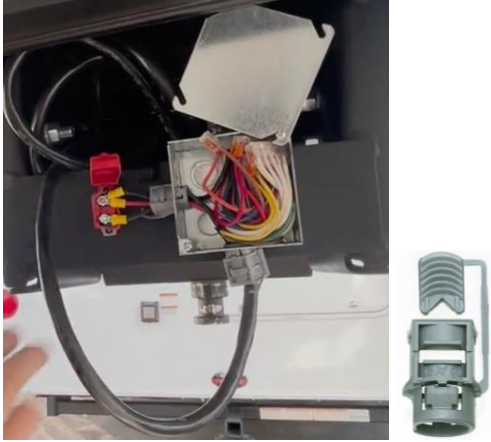
Details	Photos
<p>Model: Columbus</p> <p>VIN: 4x4fcmp27s6014763</p> <p>Fabricated Date: 8/21/2024</p>

142. Improper strain relief on seven-way wiring going into the junction box using non-metallic clamp connectors, designed for residential construction applications. A combination of improper installation of the connector and no strain relief leaves the nut on the back of the connector to come loose and come off.

143. Improper strain relief on seven-way wiring going into the junction box using non-metallic plastic push in connectors, designed for residential construction applications. A

combination of improper installation of the push-in connector, bending moments, and no strain relief leaves the nut on the back of the connector to come loose and come off.

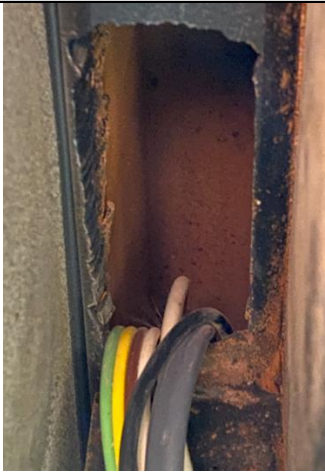
Details	Photos
<p>Model: Puma</p> <p>VIN: 4x4FPUF28KP079346</p> <p>Fabricated Date: 1/24/2019</p>

145. As the wire travel through bends with sharp edges it should be protected against physical damage by using an additional wrap or layer of equivalent material, referred to as a loom in the RV industry. Below are examples where the wires are passed through sharp edges or are exposed through sharp edges with no additional protection. Over the usage of the vehicle these spots are the shorts can take place.

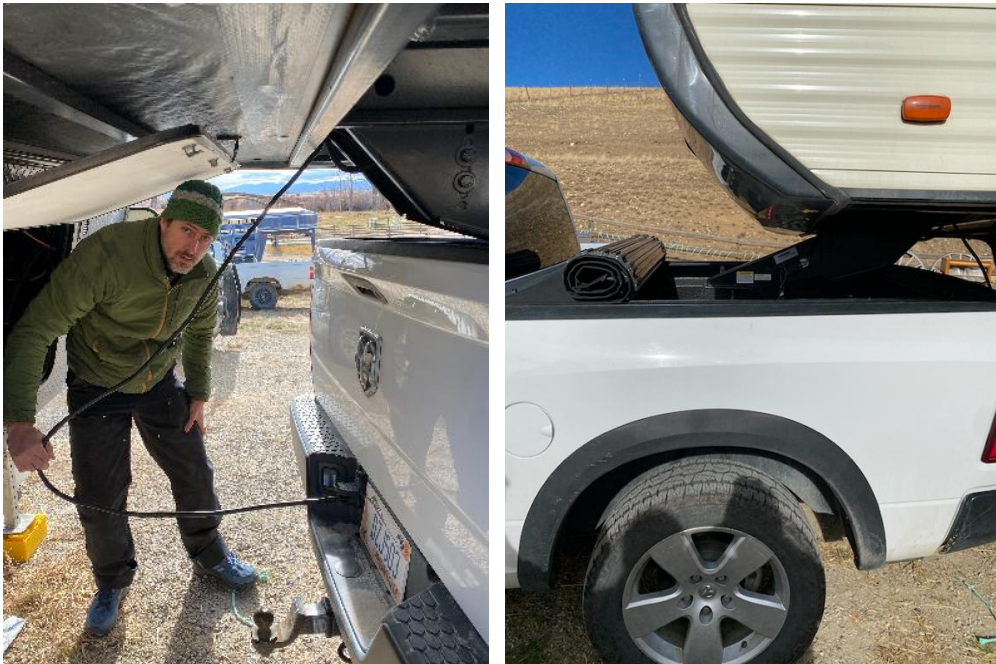
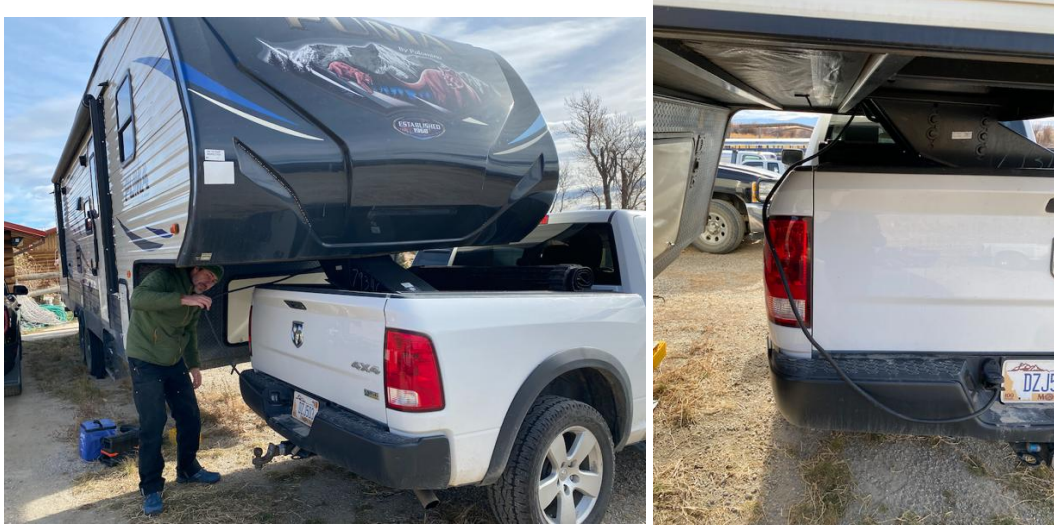
Figure 41. Photos of the 7-way cord in different geometric configurations with a vehicle

188. With regard to Forest River counsel suggesting that a “sharp turn” in Black Sandy Campground could have caused damage to the seven-way wiring, it is amply debunked by the physical layout experiments done during the November 13, 2024 inspection of the 2019 Puma, Figure 86.

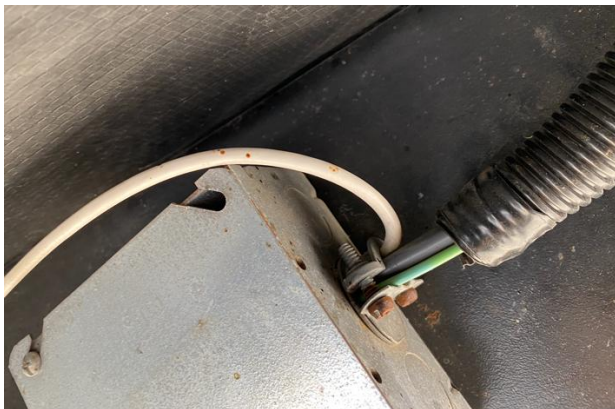
190. As shown below, a non-metallic clamp connector was used in the 2019 Puma with no additional jacket protection. According to Conway, the loom just needs to abut the connector, which is wrong.

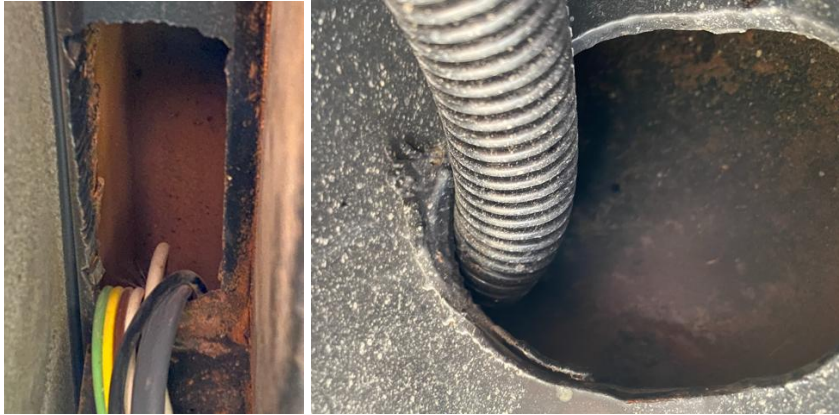
191. The chassis that Forest River uses may be purchased from Lippert; however, Forest River then makes modifications to the structure by making a hole on the fifth wheel chassis. Such holes are not finished cleanly but are left rough with burrs (sharp edges) capable of

cutting flesh many times. Once the wire enters the chassis structure, it is no longer protected with loom in the 2019 Puma inspected.

192. At the conclusion of the 2019 Puma inspection, Dr. Angle and I upgraded the seven-way wiring to a safer configuration using a plastic box, available commercially and designed specifically for the RV industry. We protected the bundle of wires going from the junction box to the battery compartment with loom, filed all of the sharp edges along the way. The total time to fix the 2019 Puma took 3 hours with two people.

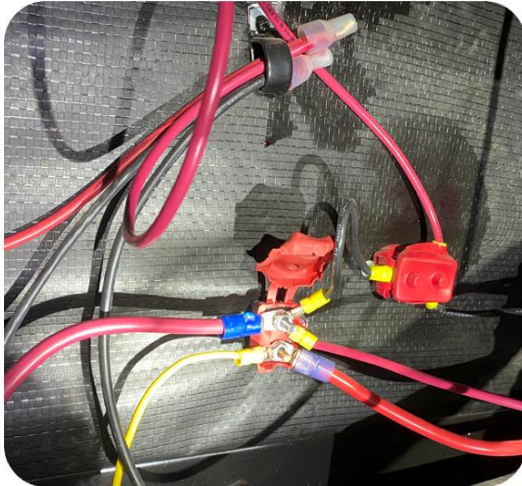
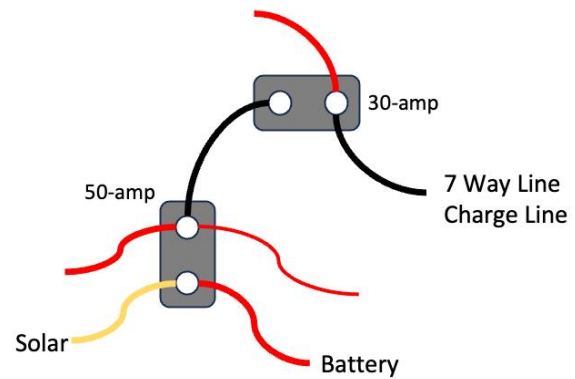
194. On November 13, 2024, we also inspected Nelson's 2020 Puma and the upgrades performed to comply with the Applicable Standards. The seven-way wiring was traced, and the charge line is now protected by a 30-amp breaker as shown below.

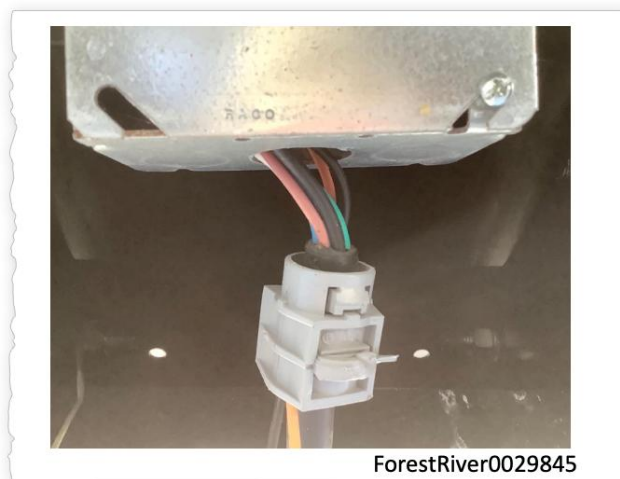
ForestRiver0029845

196. The push in connector used by Forest River routinely comes out. We observed this on new units that had never been used and on used units, and in warranty claims. The following photos show this issue.

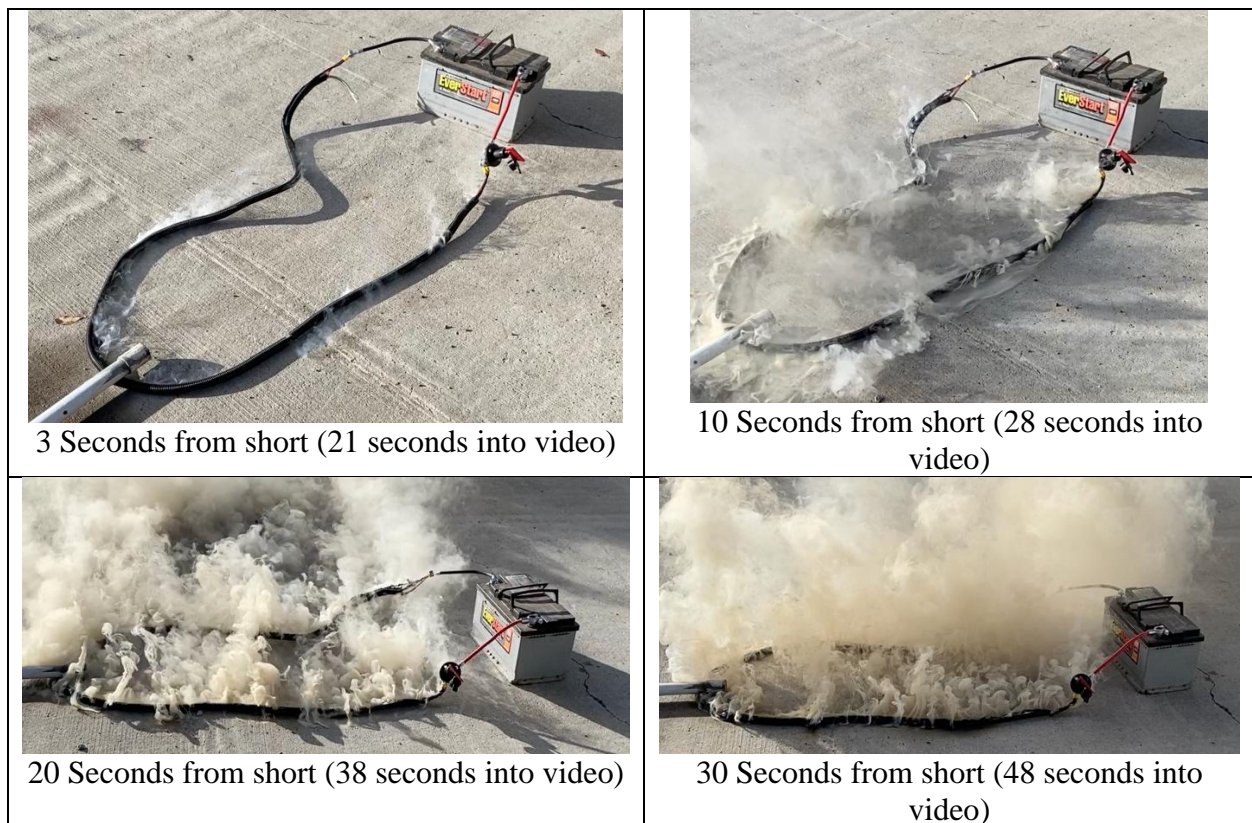
Table 13. Wiring experiment with two lines shorted Short established 18 seconds into the video

201. Once shorted the area can be engulfed in smoke in about 30 seconds, as shown in the double wire short experiment. For safety the experiment was done outside and on concrete. In a RV unit, as the insulation burns new regions of bare wire are exposed leading to new potential short locations along the route.

202. The videos show a two wires short time sequence. Table 14 shows a snapshot sequence at 3, 10, 20, and 30 seconds after the short is created.

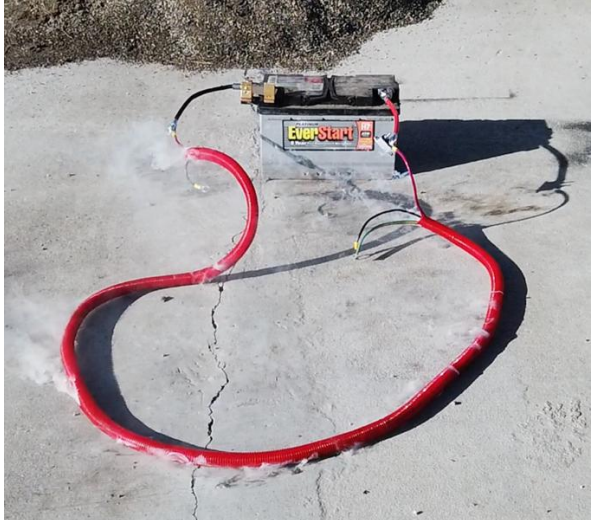
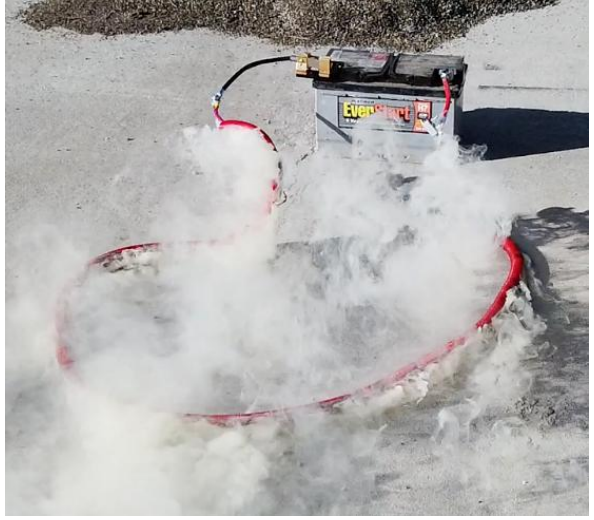
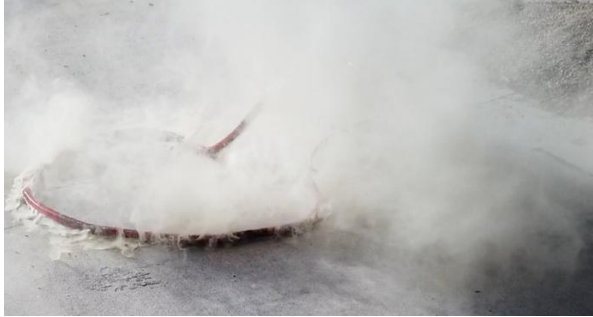
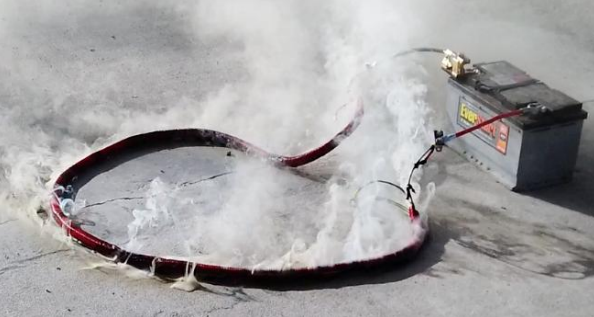
Table 14. Wiring experiment with single line shorted

205. A single wire short will also engulf the area in smoke in a period of 30 seconds, as shown in the single wire short experiment. The video shows a single wire short time sequence. Table 14 shows a snapshot sequence at 8, 14, 23, and 30 seconds after the short is created.

8 Seconds from short (40 seconds into video)	14 Seconds from short (46 seconds into video)

23 Seconds from short (55 seconds into video)	30 Seconds from short (1:02 min into video)
